**THE INC. VILLAGE OF SHOREHAM
VILLAGE HALL BUILDING**

**BUILDING CONDITIONS
SURVEY / ASSESSMENT**

February 8, 2022

Project No.: SHMV 2102

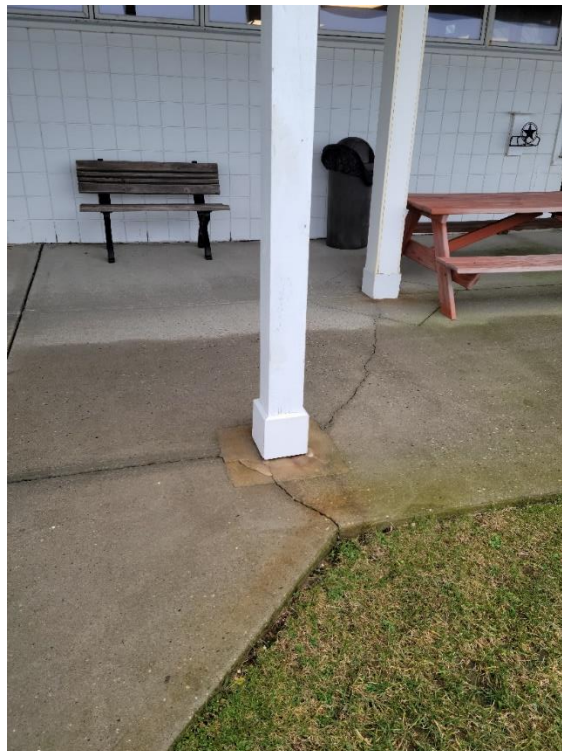
PHOTO 6

A	Cracks on patio slab on grade. (Photo 6)
	A	West (Beach access road) Fiber / cement exterior siding repaired. Annual maintenance required (Prep and paint) (Photo 7)
	A	South (Adjacent to parking) Fiber / cement exterior siding repaired. Annual maintenance required (Prep and paint) (Photo 8)
	A	Paint chipping from columns exposing existing metal to rust. (Photo 9)
	IA	Planting bed material covering column bases causing escalated deterioration. (Photo 10)
	IA	Column base plates rusting and missing anchor bolts (Photo 11)
Parking Lot / Sidewalks	G G	South Parking Lot, Sidewalk and accessible sidewalk curb cut Concrete walkways and accessible curb cuts are in good condition. (Photo 12) Parking lot is in good condition. (Photo 13)
Door / Entrances	G G IA IA CV A	East (Main Entry) Alum/ Glass entries are in good condition. Hardware replaced at time of survey. (Photo 14) West (Kitchen) Kitchen entry in door is in good condition. Saddle in poor condition. (Photo 15) Exterior stairs leading from kitchen are staring to rust. Treads and landing are starting to deteriorate. Temporary repair (diamond plate) was provided. (Photo's 16, 17, 18) Existing Railing and Guard not sufficient to meet current code requirements (Photo's 19) Retaining wall between planting bed and pathway to kitchen cracking. (Photo's 20)

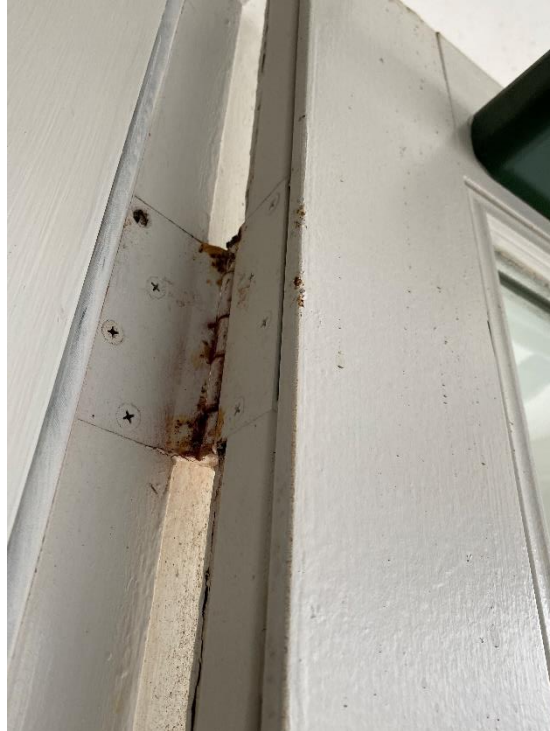
PHOTO 21

<p>A IA IA IA PR/IL</p> <p>IA</p> <p>G</p> <p>A</p> <p>PR/IL</p> <p>A</p>	<p>West (Egress from Assembly Space to Deck) Exterior door showing wear and tear. Rust exposed from previously refinished areas. (Photo 21) Weather stripping starting to deteriorate. (Photo 22) Part of saddle missing (Photo 23) Missing screws securing hinges to frame. (Photo 24)</p> <p>West / North and North / East (Main Assembly Space / Deck) Weathered Sliding Glass doors. Bottom rail and interlocking rail starting to rot. Interlocking rail trim pulling from panel. (Photo 25, 26) Damage to side jamb (Photo 27) Damaged saddle / non ADA compliant (Photo 28, 29)</p> <p>West / North and North / East (Lower-Level Assembly) Non energy efficient store front System. Door, removable mullion and hardware starting to rust. (Photo 30) Cracks in sidelight. (Photo 31)</p> <p>Garage Door Replace weatherstripping (Photo 32)</p>
Windows	<p>IA IA</p> <p>G</p>	<p>Lower-Level Aluminum Clad (Awning windows) Perimeter window caulking cracked/ separated from window & masonry allowing moisture and air penetrate. Operating hardware missing on several units. (Photo 33)</p> <p>Main-Level Vinyl Clad (Casement windows) Operating hardware missing broke on three of the units. (Photo 34)</p>

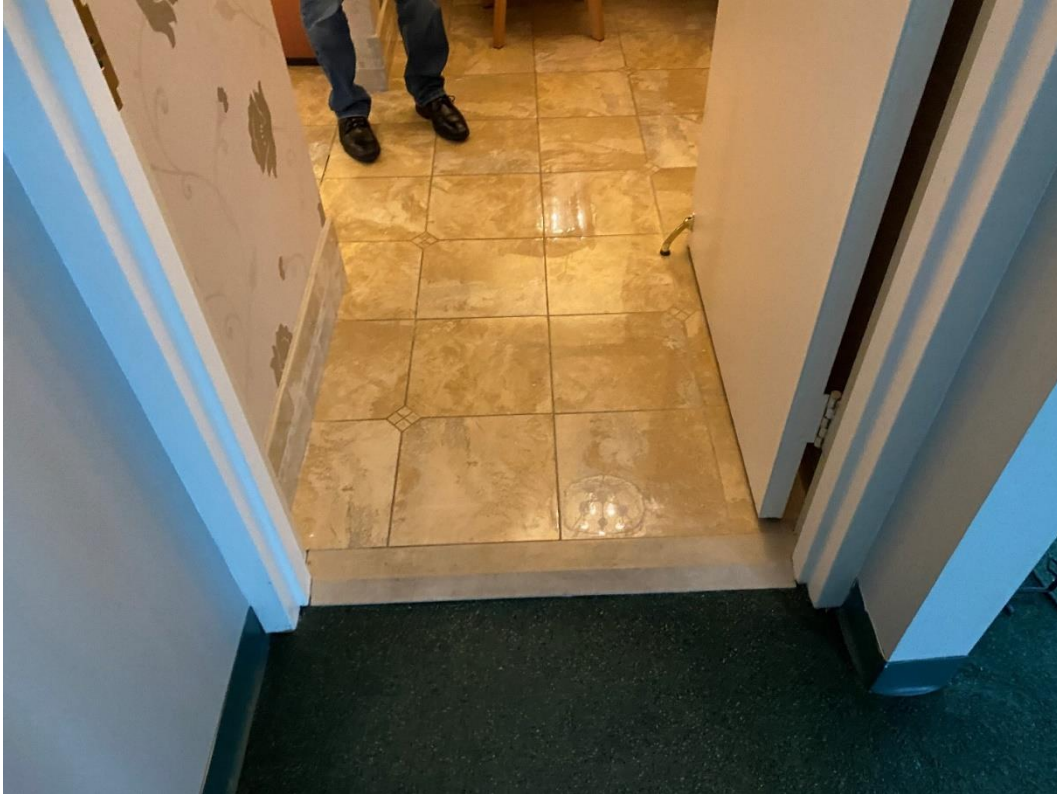
PHOTO 35

Toilets	<p>CV</p> <p>G</p> <p>G</p> <p>CV</p> <p>A</p> <p>IA</p>	<p>Women's Toilet Entry / Exit clearance and Saddle do not meet accessible requirements. (Photo 35) Clearances and grab bars added to stalls not sufficient to current requirements (Photo 36) Wallpaper dated, starting to show typical wear and tear. (Photo 37) Updated stone counters and lavatories (Photo 38)</p> <p>Men's Toilet Entry clearance and Saddle do not meet accessible requirements (Photo 39) Toilet partitions starting to rust. (Photo 40) Outdated floor tiles starting to require repairs (Photo 41)</p>
Roof	<p>G</p> <p>A</p> <p>G</p> <p>A</p>	<p>Asphalt Roof Shingle Single Main roofing material was in good condition. (Photo 42) Asphalt Roof cap shingles starting to pull from the roof - (Photo 43)</p> <p>Standing seam Metal Roof Standing Seam Metal Roof – Normal wear and tear. (Photo's 44)</p> <p>Fascia / Trim boards Further investigation should be conducted at flashing / fascia boards. Indications showing water penetrating surface. (Photo 45)</p>

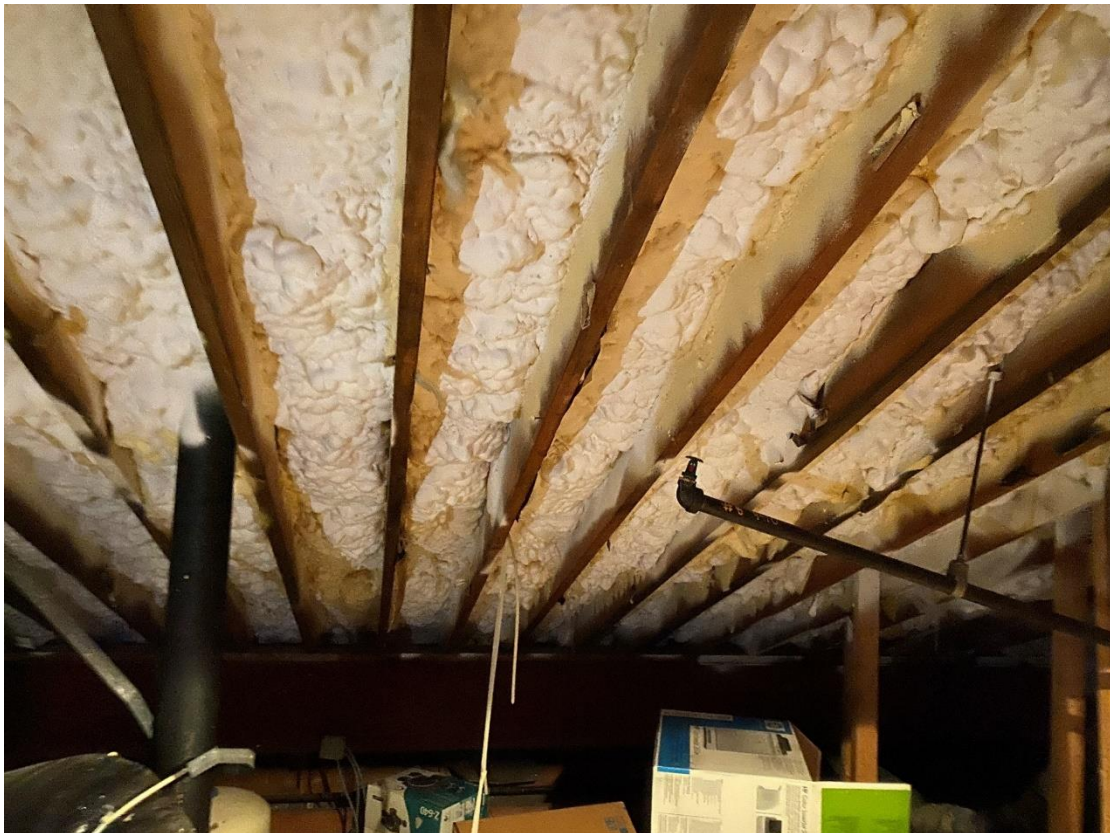
PHOTO 46

Insulation Sprayed Insulation - inconsistent thickness lacking continuous r value (Photo 46)
Roof Gutters and Leaders	G	Regular maintenance - clean gutters and leaders on an annual basis. (Photo 47)
Kitchen	IA A G	Ceramic tile base cracked. (Photo 48) Galvanized metal wall panel in poor condition. Cleaning panel would determine recommendation. (Photo 49) Unutilized Walk-in refrigerator resting on existing flooring. Inefficient installation May be causing issues with floor assembly. Evidence indicates damage and partial repairs. (Photo 50)
Main Level Assembly	A G	Further investigate clearstory windows. Water staining on clearstory gypsum board walls indicating water might be penetrating building envelope in the area above the dance floor. (Photo 51) Normal wear and tear of finishes. (Gypsum board, Paint, Carpet, Trim, Etc.) Minor finish repairs required.
Boiler Room	CV CV CV	Patch Gypsum Board ceiling to provide required fire separation (Photo 52) Lack of fireproofing assembly at penetrations. (Photo x,x) Provide proper rated door, frame, and hardware between occupancies. (Photo 53)

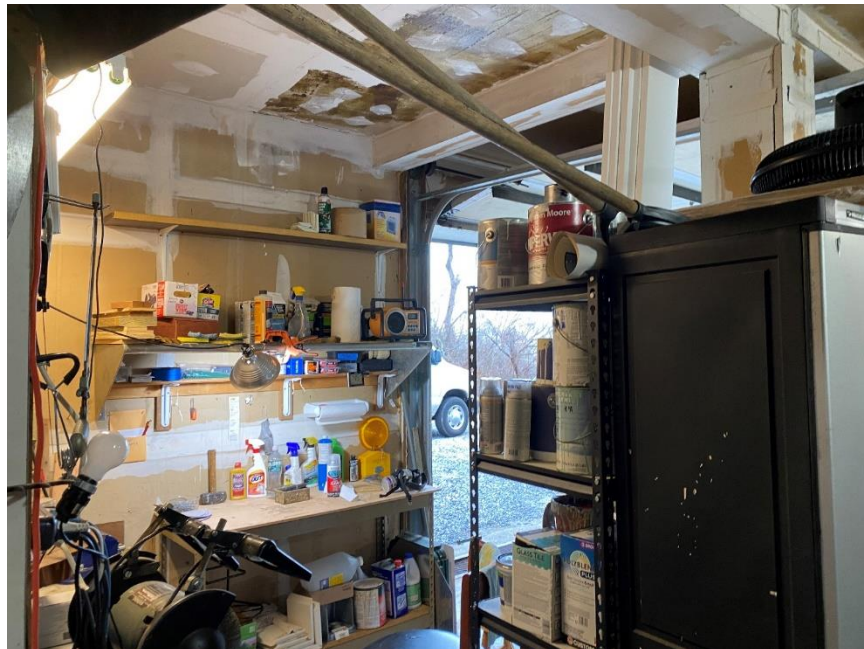
PHOTO 54

Garage	CV CV	Patch Gypsum Board ceiling to provide required fire separation (Photo 54) Provide proper rated door, frame, and hardware between occupancies. (Photo 55)
Secondary Kitchenette	A	Outdated finishes and fixtures. Laminate countertop starting to peel. (Photo 56)
Circulation Stair	CV	Top landing lacking guardrail and railing assembly for current code requirements. (Photo 57)
Exterior Rear Deck	G IA IA CV IA A IA	Wood Deck Deck joists and framing in good condition. (Photo 58) Decking starting to rot and splinter in various locations. Existing decking replaced in several locations (Photo 59) Decking finish starting to deteriorate. Moss / mildew starting to build up on surface of decking (Photo 60) Existing Railing and Guard not sufficient to meet current code requirements (Photo 61) Railing finish peeling causing exposed metal to rust. (Photo 62) Metal deck fasteners starting to rust (Photo 63) Column bases starting to rot. Maintenance repairs present at some locations. (Photo 64) Refinish existing rim joist (Prep and paint). (Photo 65)

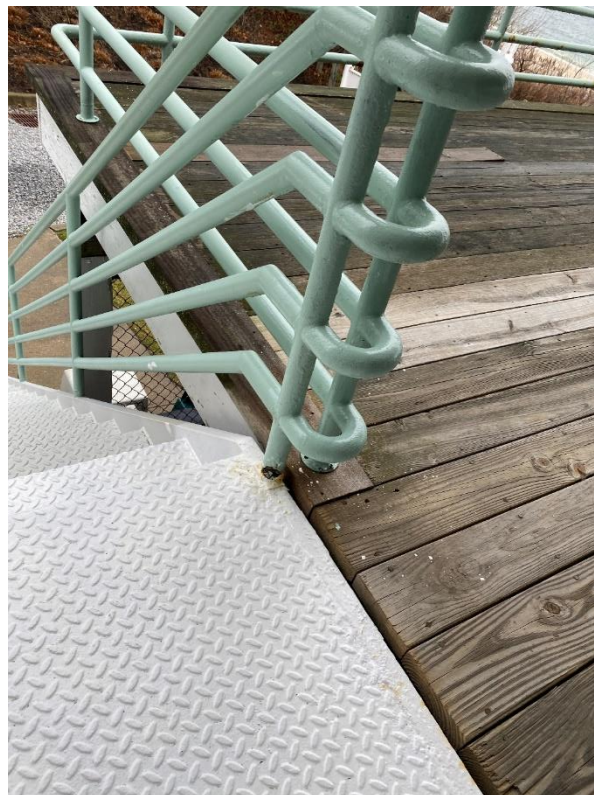
PHOTO 66

PR/IL IA CV	Metal Stairs leading down to grade Gap / lift between diamond plate landing and adjacent wood decking creating a potential tripping hazard. Railing post separated from stair stringer (Photo 66) Existing Railing and Guard not sufficient to meet current code requirements (Photo's 67)
LULA / Elevator	G G	Elevators updated in 2020 (Photo's 68) Elevator appears to in good condition

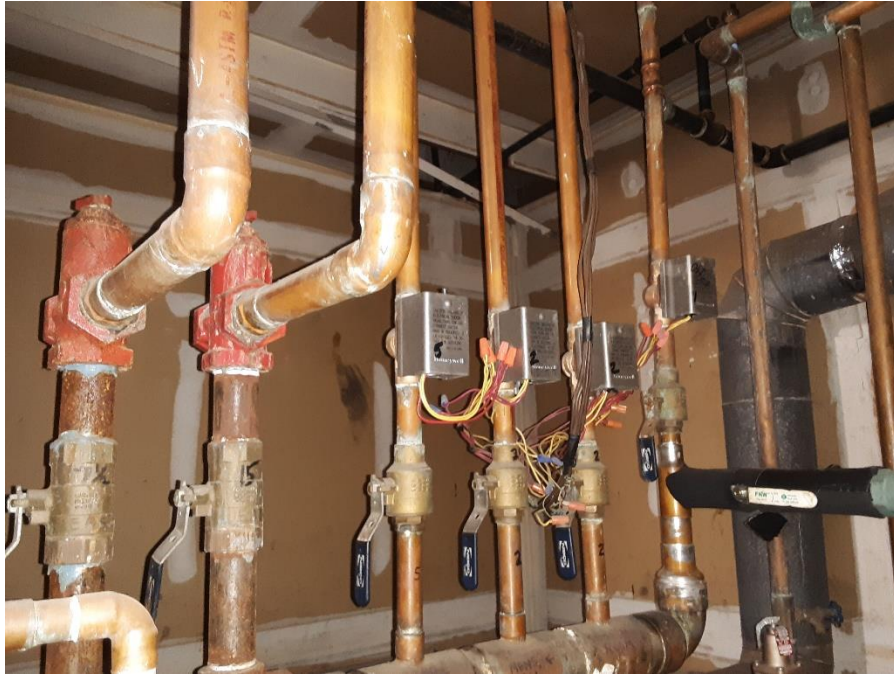
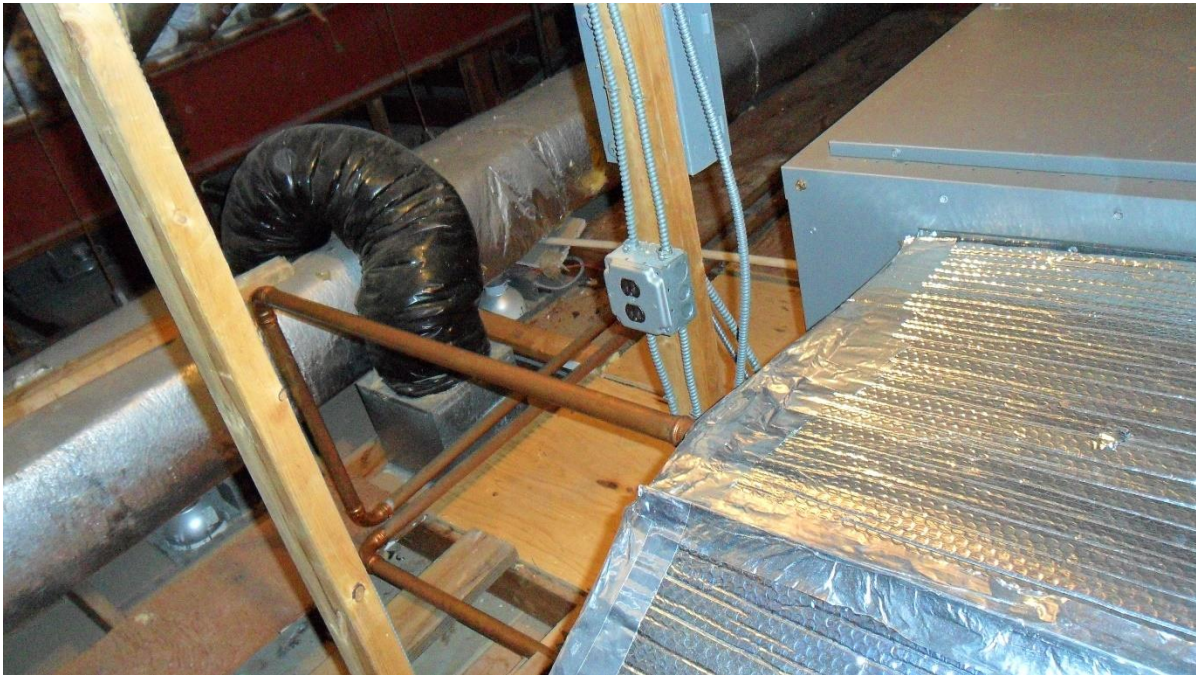
Item	Condition	Comments
Heating Oil Tank	G	No deficiencies observed.
Heating Boiler	G	Oil fired HB Smith 480MBH with Carlin (2019) oil burner all appear to be in good working order.
Heating Piping	G	All heating piping should be insulated per energy code.
Zone Pumps (4)	A	Appear to be in fair / working condition. Should be scheduled to be replaced within 2-5 years.
Hydronic Heating (Lower Level)	G	No deficiencies observed.
Air Handling Units (Upper Level)	IA	The air handling units are in good condition, however are lacking a source of mechanical ventilation. Refer to Report Dated April 2, 2021 (attached)
Lower Level Ventilation	IA	Refer to Report Dated April 2, 2021 (attached)
Controls	G	No deficiencies observed.

Insulate heating hot water piping throughout building. See Photos M-1 & M-2.

Estimated Budget: \$5,000

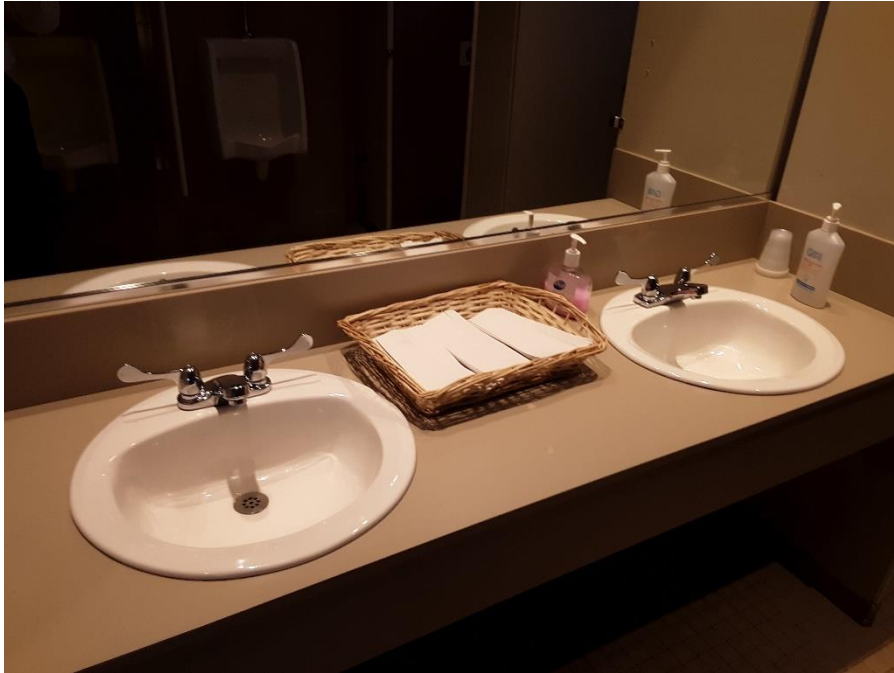
PHOTO P-1

Item	Condition	Comments
Propane Tank	G	No deficiencies observed.
Domestic Hot Water	G	No deficiencies observed.
Plumbing Fixtures	G	Consider replacing manual valves with battery operated hands free operators for sanitary reasons.

Replace bathroom fixtures and flush valves to hands-free. See Photo P-1

Estimated Budget: \$10,000

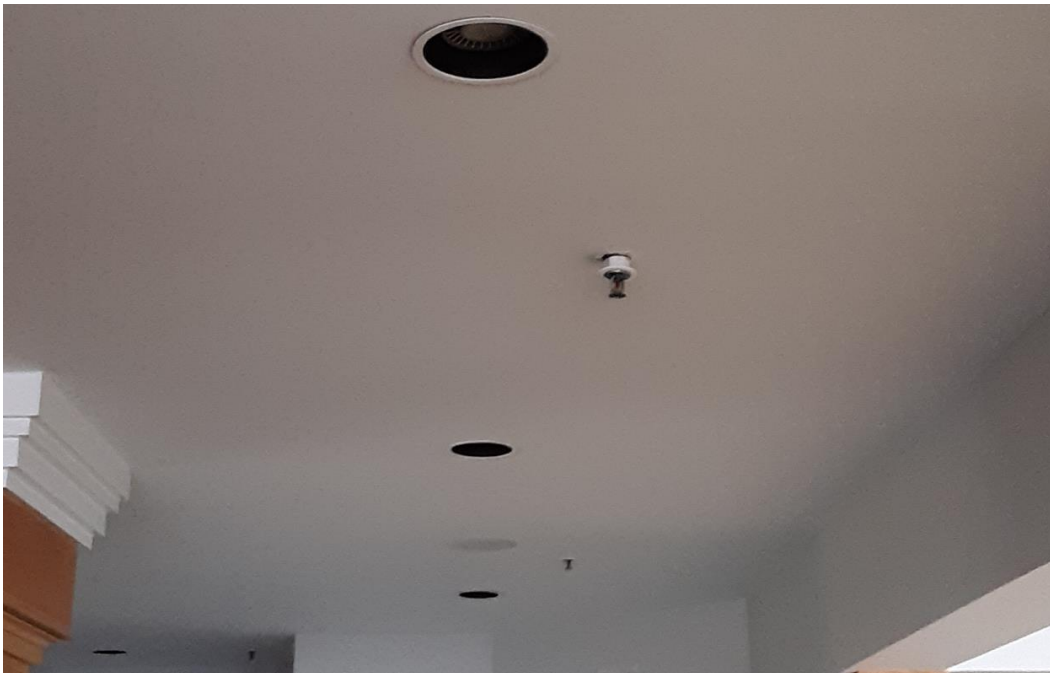
PHOTO F-1

Item	Condition	Comments
Kitchen Ansul System	G	Inspection Tag dated Sept, 2021. No deficiencies observed.
Main Level Sprinkler Heads	G	A number of heads are sagging. Consider adjusting heights.
Attic Sprinkler Piping	PR/IL	Although the attic building envelope is insulated there is a risk of sprinkler piping freezing in the attic. It is suggested to install three electric unit heaters in the attic.

Adjust main level sprinkler heads. See Photo F-1

Estimated Budget: \$2,000

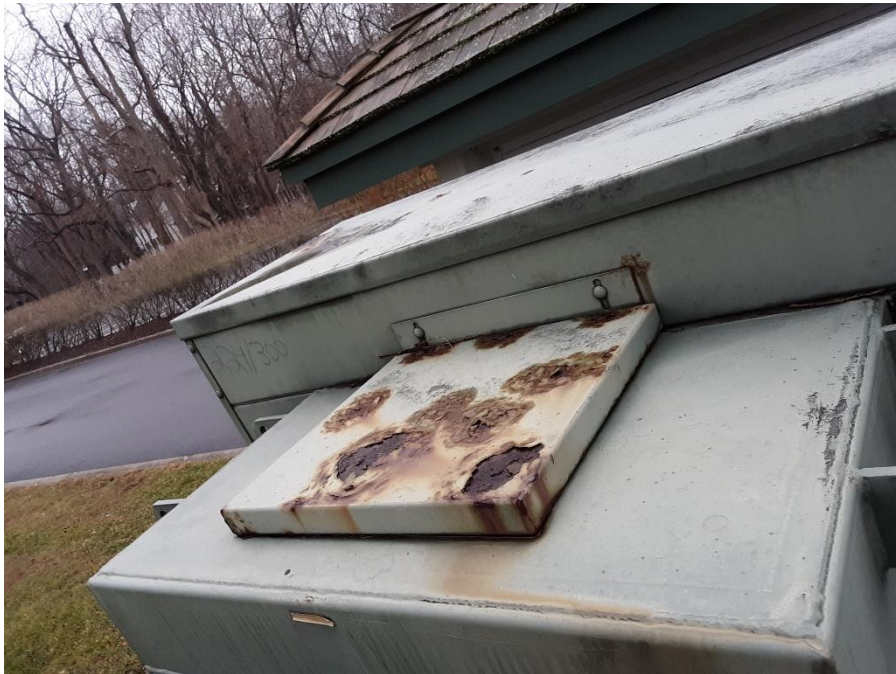
PHOTO E-1

Item	Condition	Comments
Electric Utility Transformer	PL/IR	Access panel heavily corroded. Replace to prevent water intrusion. Request for transformer replacement from local utility company (PSE&L)
Lower Level Lighting Fixtures	G	Consider upgrading T5 fixtures to LED for energy usage reduction (energy efficiency)

Request replacement of transformer with local utility (PSE&L). See Photo E-1

Estimated Budget: Confirm with local utility Company
