**THE INC. VILLAGE OF SHOREHAM
VILLAGE HALL BUILDING**

**BUILDING CONDITIONS
SURVEY / ASSESSMENT**

February 8, 2022

Project No.: SHMV 2102

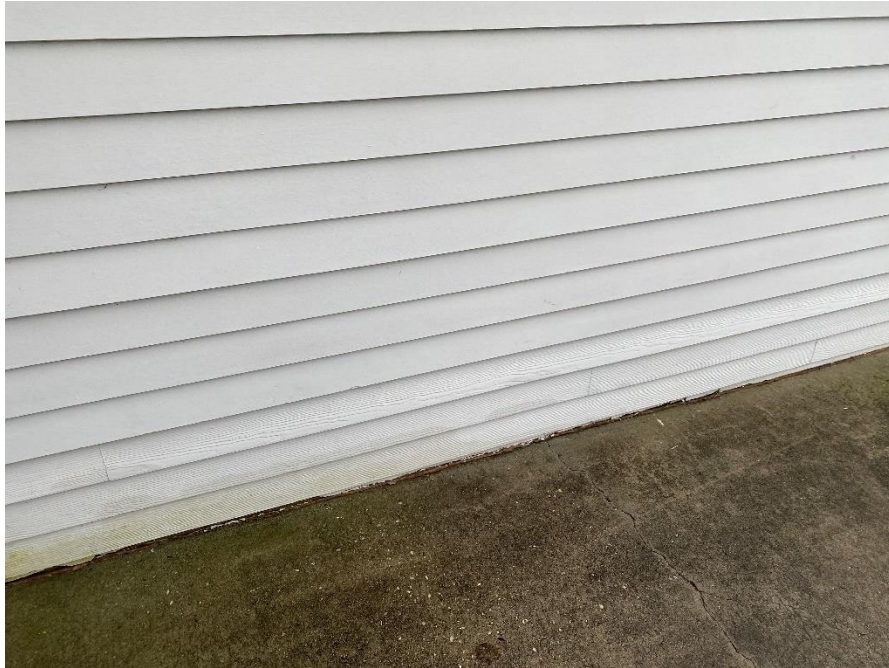
PHOTO 1

Item	Condition	Comments
Building structures	G	First Floor framing: Wood Floor Trusses (Observable only) supported by Steel columns and beams. Ceiling framing: conventional framing (Observable only) supported by Steel columns and beams. Roof framing: Metal deck (Observable only) supported by Steel columns and beams.
Primary Building Materials	G G A/I	Foundation (observable only) - Concrete foundation walls / pile caps on treated timber piles. Exterior walls –Wood Frame Wall – Fiber / cement exterior siding, Aluminum Clad windows, Aluminum Clad Sliding Glass Doors.
Facade	A	East Façade (Main Entry) Fiber / cement exterior siding repaired. Annual maintenance required (Prep and paint) (Photo 1)
	A	Column wraps / trim staring to weather. (Photo 2)
	A	North (Long Island Sound) Fiber / cement exterior siding repaired. Annual maintenance required (Prep and paint) (Photo 3)
	PR/IL	Cracking at exterior of foundation walls. Further investigation required to determine required actions. (Photo 4,5)

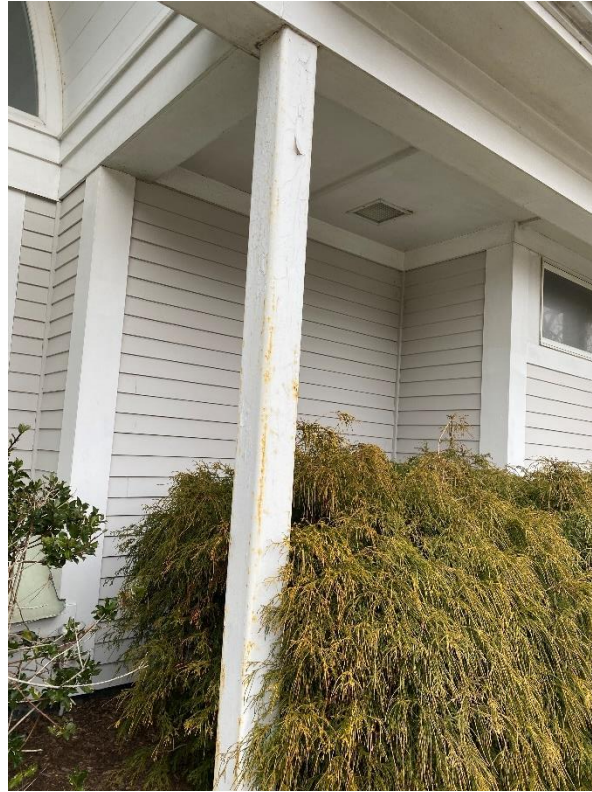
PHOTO 9

A	Cracks on patio slab on grade. (Photo 6)
	A	West (Beach access road) Fiber / cement exterior siding repaired. Annual maintenance required (Prep and paint) (Photo 7)
	A	South (Adjacent to parking) Fiber / cement exterior siding repaired. Annual maintenance required (Prep and paint) (Photo 8)
	A	Paint chipping from columns exposing existing metal to rust. (Photo 9)
	IA	Planting bed material covering column bases causing escalated deterioration. (Photo 10)
	IA	Column base plates rusting and missing anchor bolts (Photo 11)
Parking Lot / Sidewalks	G G	South Parking Lot, Sidewalk and accessible sidewalk curb cut Concrete walkways and accessible curb cuts are in good condition. (Photo 12) Parking lot is in good condition. (Photo 13)
Door / Entrances	G G IA IA CV A	East (Main Entry) Alum/ Glass entries are in good condition. Hardware replaced at time of survey. (Photo 14) West (Kitchen) Kitchen entry in door is in good condition. Saddle in poor condition. (Photo 15) Exterior stairs leading from kitchen are staring to rust. Treads and landing are starting to deteriorate. Temporary repair (diamond plate) was provided. (Photo's 16, 17, 18) Existing Railing and Guard not sufficient to meet current code requirements (Photo's 19) Retaining wall between planting bed and pathway to kitchen cracking. (Photo's 20)

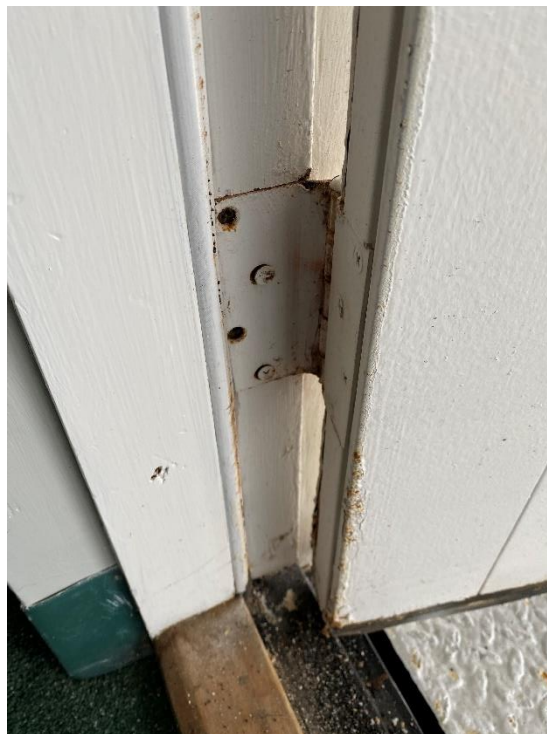
PHOTO 24

<p>A IA IA IA PR/IL</p> <p>IA</p> <p>G</p> <p>A</p> <p>PR/IL</p> <p>A</p>	<p>West (Egress from Assembly Space to Deck) Exterior door showing wear and tear. Rust exposed from previously refinished areas. (Photo 21) Weather stripping starting to deteriorate. (Photo 22) Part of saddle missing (Photo 23) Missing screws securing hinges to frame. (Photo 24)</p> <p>West / North and North / East (Main Assembly Space / Deck) Weathered Sliding Glass doors. Bottom rail and interlocking rail starting to rot. Interlocking rail trim pulling from panel. (Photo 25, 26) Damage to side jamb (Photo 27) Damaged saddle / non ADA compliant (Photo 28, 29)</p> <p>West / North and North / East (Lower-Level Assembly) Non energy efficient store front System. Door, removable mullion and hardware starting to rust. (Photo 30) Cracks in sidelight. (Photo 31)</p> <p>Garage Door Replace weatherstripping (Photo 32)</p>
Windows	<p>IA IA</p> <p>G</p>	<p>Lower-Level Aluminum Clad (Awning windows) Perimeter window caulking cracked/ separated from window & masonry allowing moisture and air penetrate. Operating hardware missing on several units. (Photo 33)</p> <p>Main-Level Vinyl Clad (Casement windows) Operating hardware missing broke on three of the units. (Photo 34)</p>

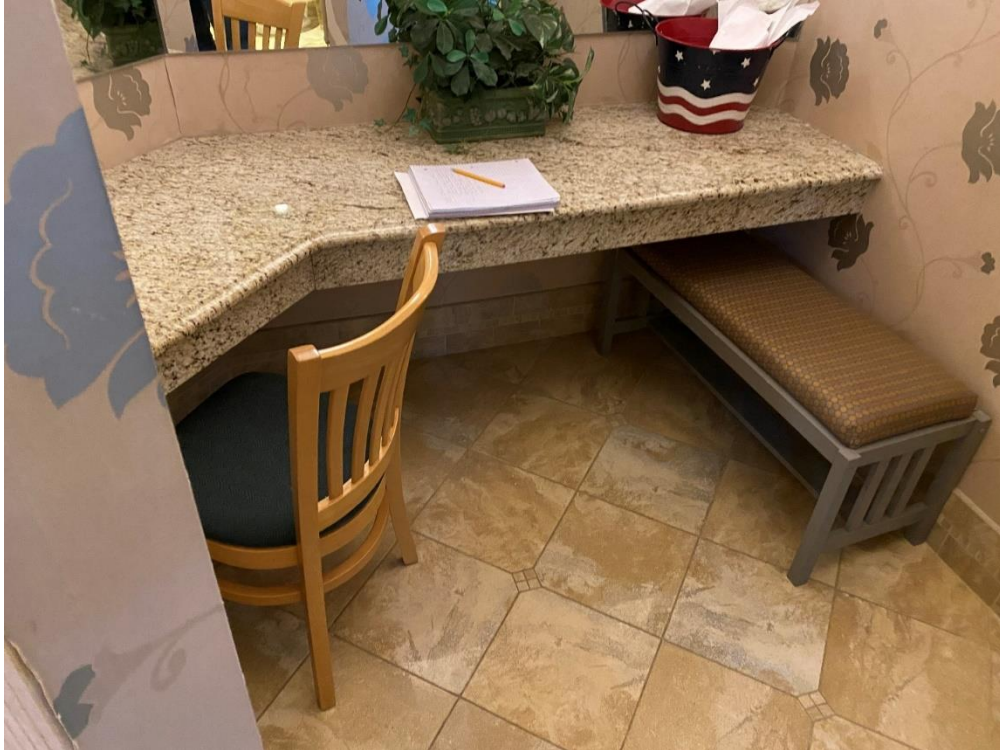
PHOTO 37

Toilets	<p>CV</p> <p>G</p> <p>G</p> <p>CV</p> <p>A</p> <p>IA</p>	<p>Women's Toilet Entry / Exit clearance and Saddle do not meet accessible requirements. (Photo 35) Clearances and grab bars added to stalls not sufficient to current requirements (Photo 36) Wallpaper dated, starting to show typical wear and tear. (Photo 37) Updated stone counters and lavatories (Photo 38)</p> <p>Men's Toilet Entry clearance and Saddle do not meet accessible requirements (Photo 39) Toilet partitions starting to rust. (Photo 40) Outdated floor tiles starting to require repairs (Photo 41)</p>
Roof	<p>G</p> <p>A</p> <p>G</p> <p>A</p>	<p>Asphalt Roof Shingle Single Main roofing material was in good condition. (Photo 42) Asphalt Roof cap shingles starting to pull from the roof - (Photo 43)</p> <p>Standing seam Metal Roof Standing Seam Metal Roof – Normal wear and tear. (Photo's 44)</p> <p>Fascia / Trim boards Further investigation should be conducted at flashing / fascia boards. Indications showing water penetrating surface. (Photo 45)</p>

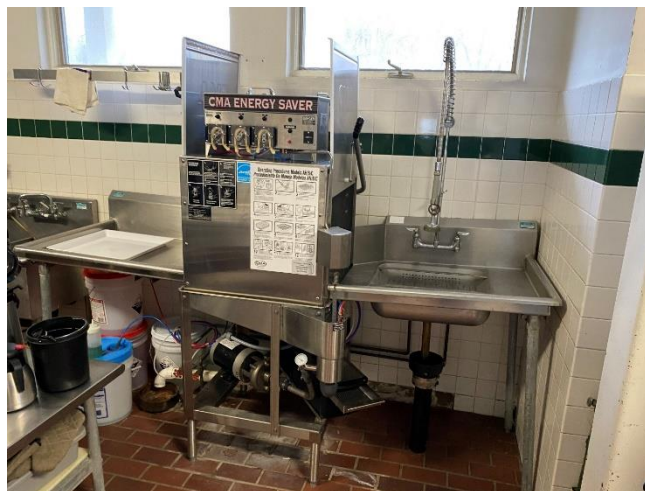
PHOTO 48

Insulation Sprayed Insulation - inconsistent thickness lacking continuous r value (Photo 46)
Roof Gutters and Leaders	G	Regular maintenance - clean gutters and leaders on an annual basis. (Photo 47)
Kitchen	IA A G	Ceramic tile base cracked. (Photo 48) Galvanized metal wall panel in poor condition. Cleaning panel would determine recommendation. (Photo 49) Unutilized Walk-in refrigerator resting on existing flooring. Inefficient installation May be causing issues with floor assembly. Evidence indicates damage and partial repairs. (Photo 50)
Main Level Assembly	A G	Further investigate clearstory windows. Water staining on clearstory gypsum board walls indicating water might be penetrating building envelope in the area above the dance floor. (Photo 51) Normal wear and tear of finishes. (Gypsum board, Paint, Carpet, Trim, Etc.) Minor finish repairs required.
Boiler Room	CV CV CV	Patch Gypsum Board ceiling to provide required fire separation (Photo 52) Lack of fireproofing assembly at penetrations. (Photo x,x) Provide proper rated door, frame, and hardware between occupancies. (Photo 53)
